**NISTIR 4868**

# **Interim Report: Preliminary Sitewide Survey of Reinforced Concrete Structural Deterioration at NIST**

**Lawrence I. Knab  
Research Civil Engineer**

August 1992

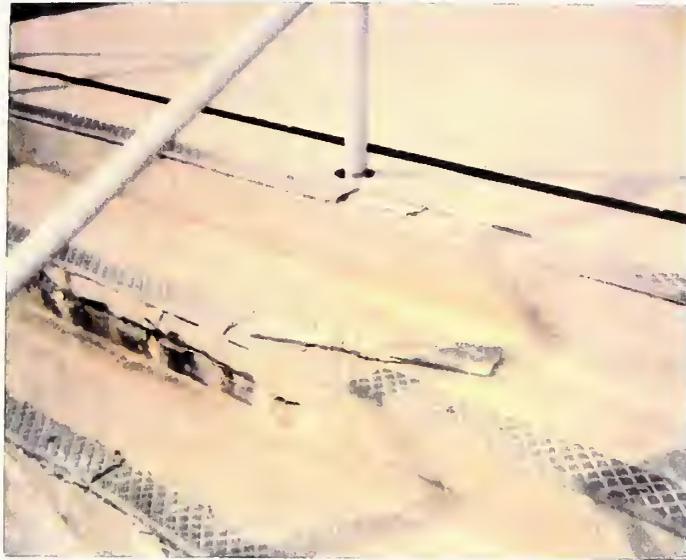
FIGURE 48

*BUILDING 205 - FRONT STAIRS*

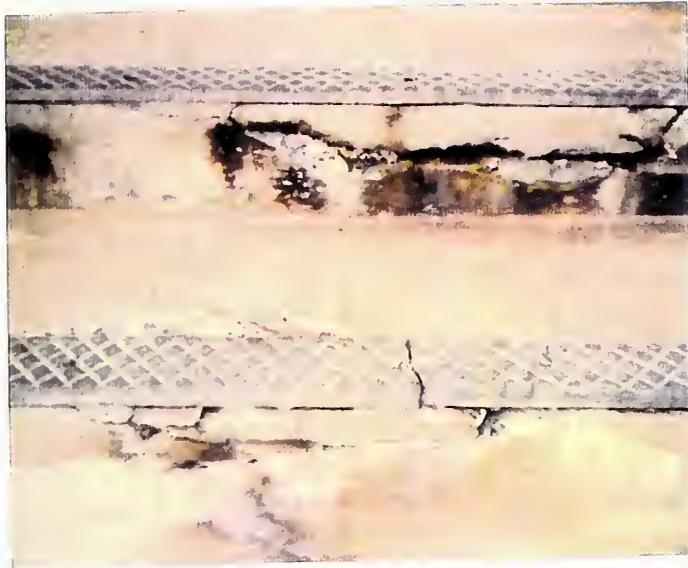
*BUILDING 205 - FRONT STAIRS*

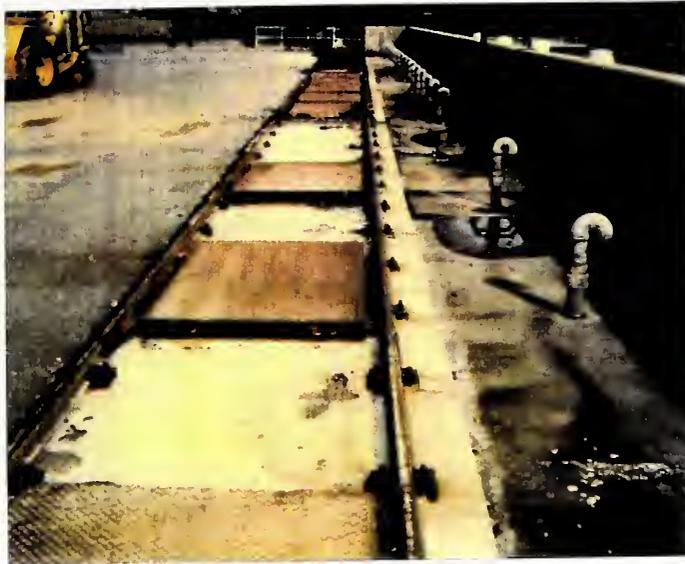
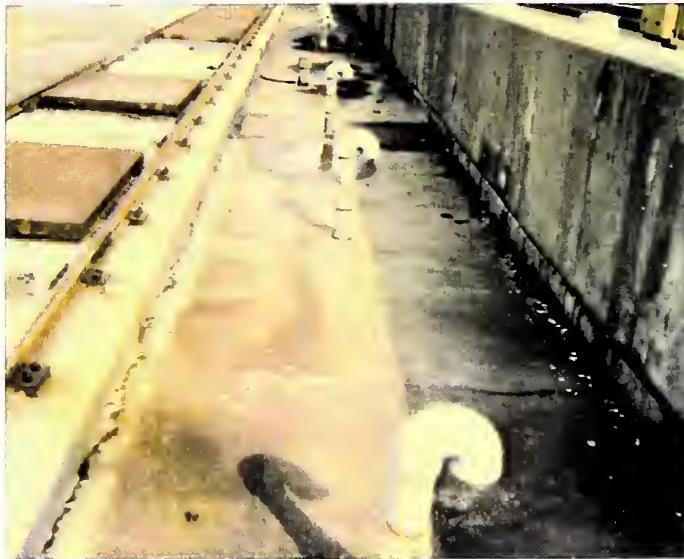
FIGURE 50

*BUILDING 206 - STORAGE BINS ROOF*

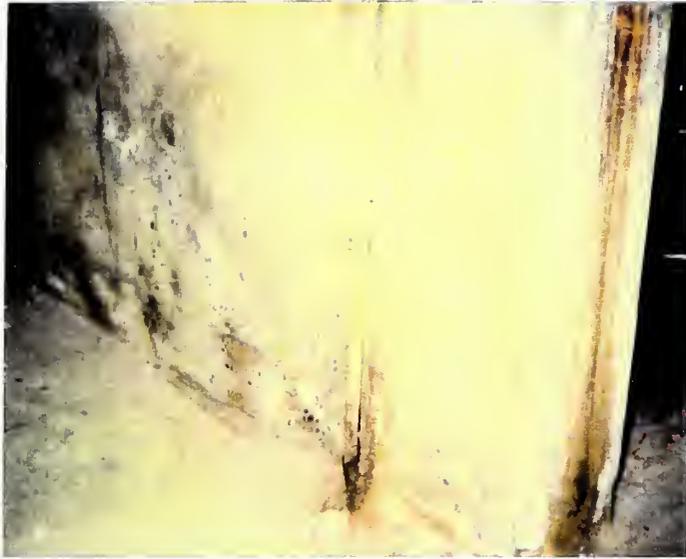
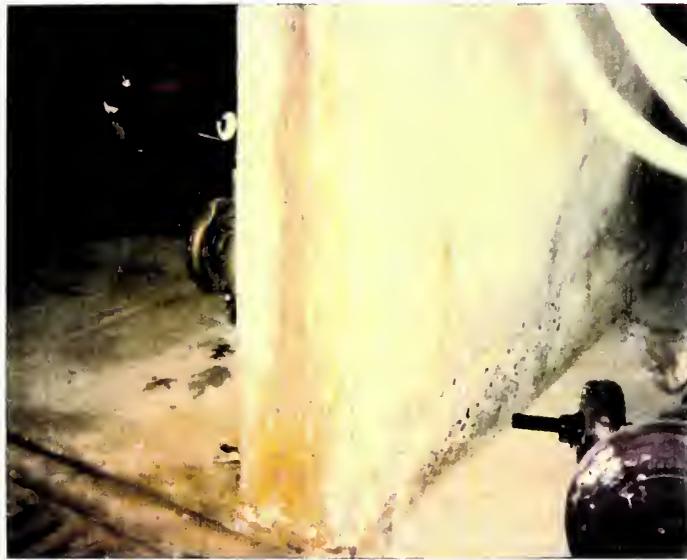
FIGURE 51

*BUILDING 206 - STORAGE BINS*

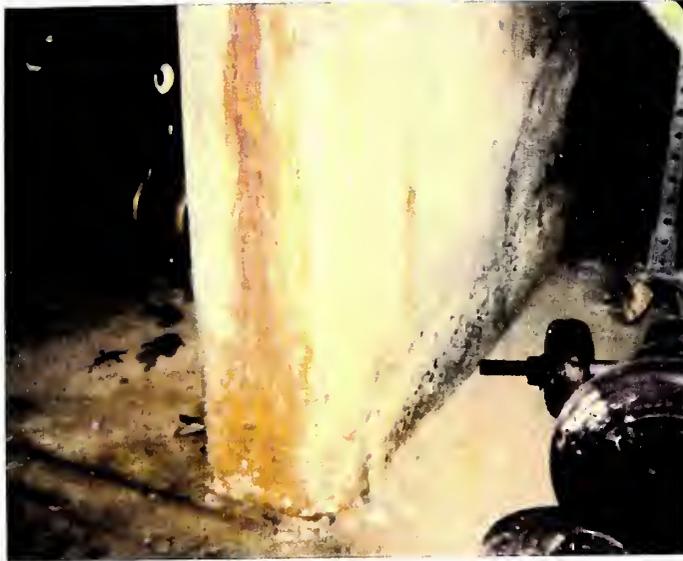
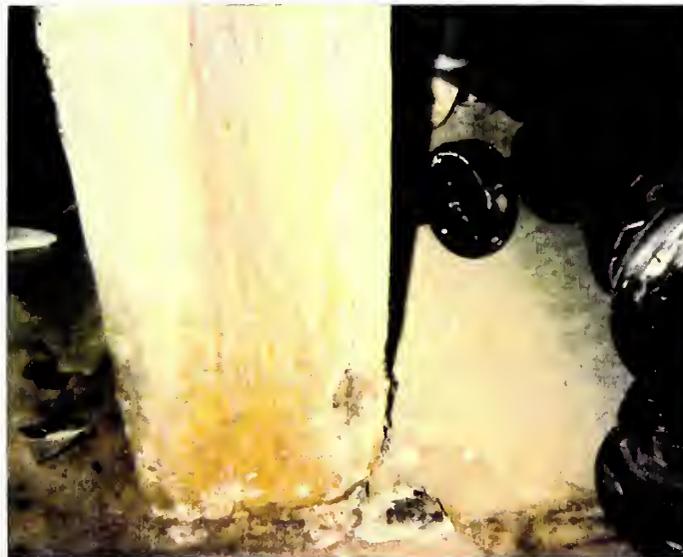
FIGURE 52

*BUILDING 206 - STORAGE BINS*

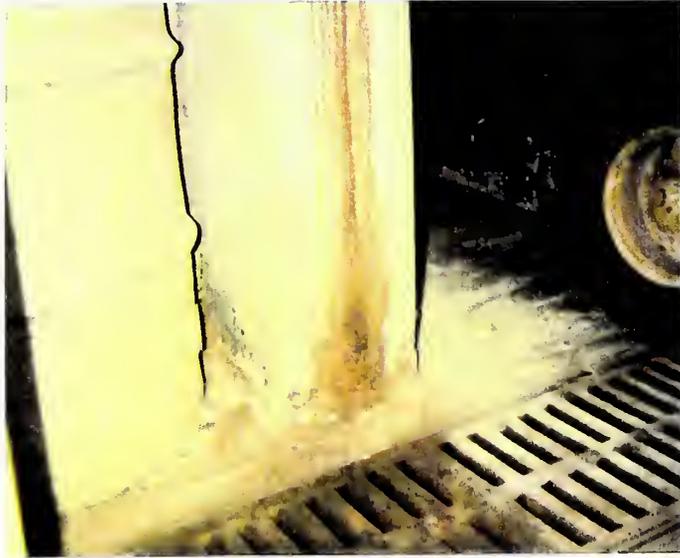
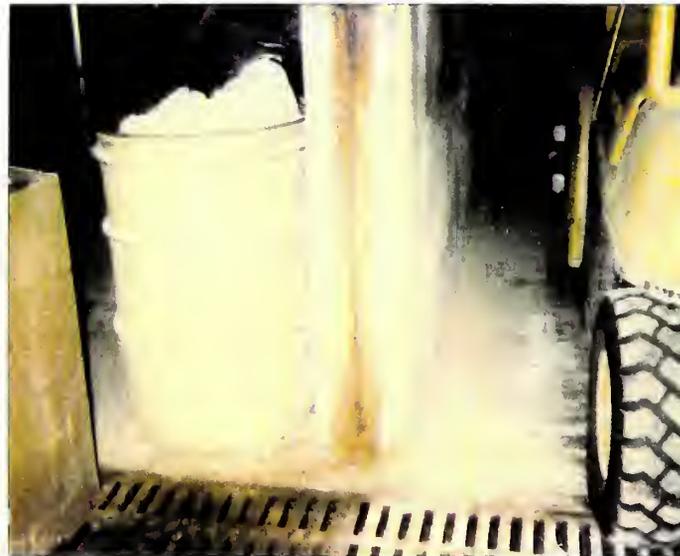
FIGURE 53

*BUILDING 206 - STORAGE BINS*

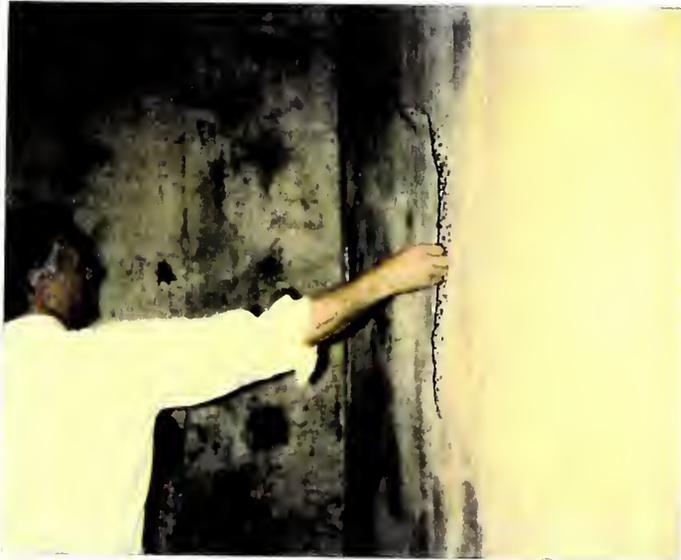
*BUILDING 206 - TOP STORAGE BINS*

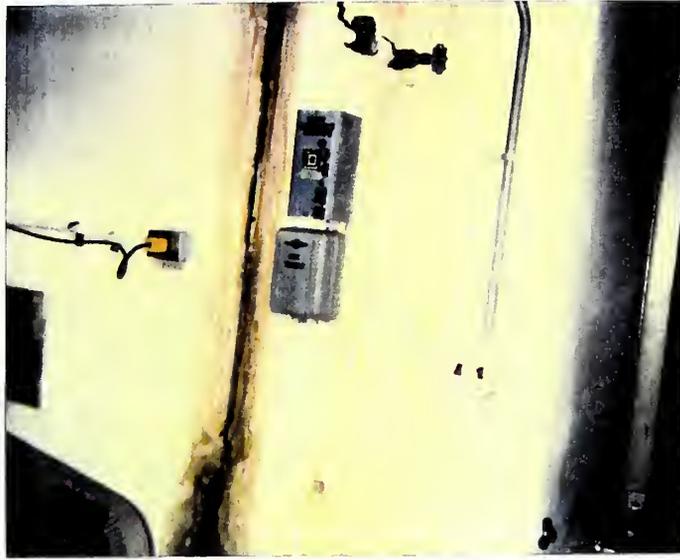
*BUILDING 206 - TOP STORAGE BINS*

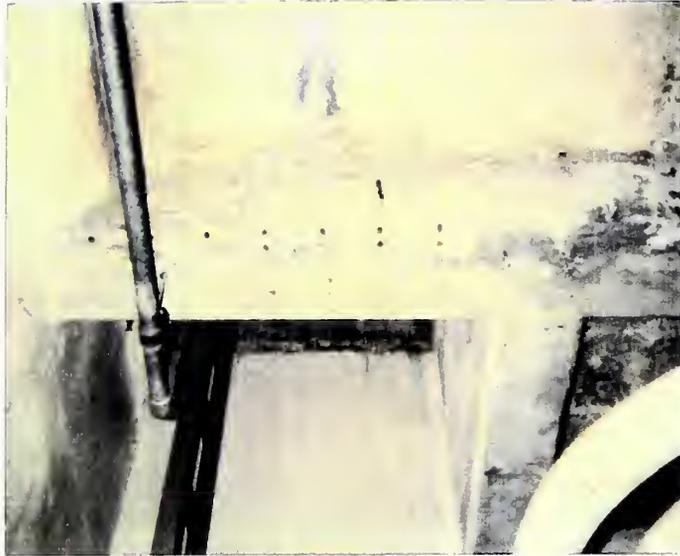
FIGURE 56

*BUILDING 220 - MECHANICAL ROOM  
EXPANSION JOINT*

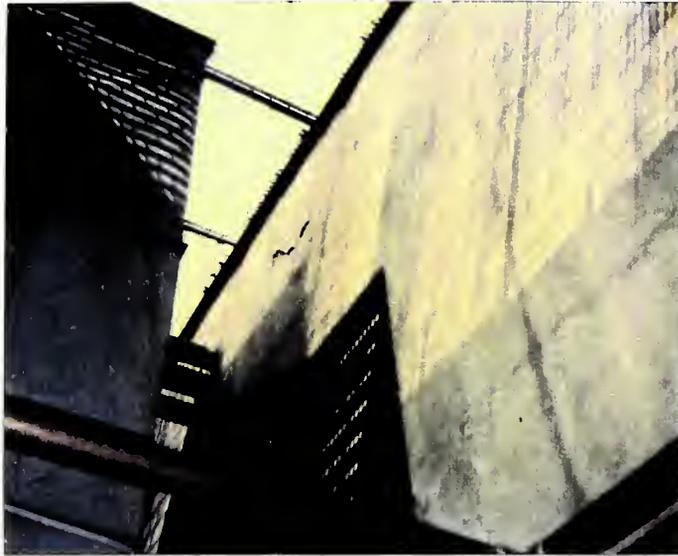
FIGURE 57

*BUILDING 226 - TRANSFORMER ROOM*

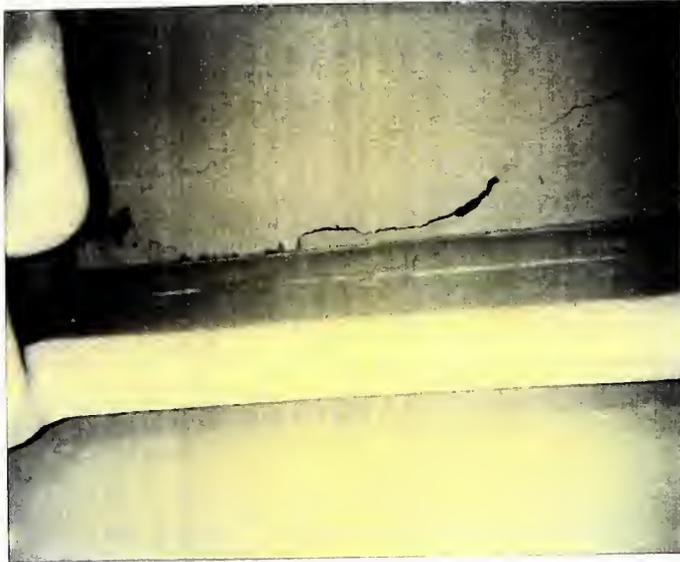
FIGURE 59

*BUILDING 233 ROOF SLAB, ROOM A121*

15. Bldg. 233, Rm. A 121, delamination in reinforced concrete roof slab due to apparent water leakage, 11 to 12 m (36 to 40 ft) above the floor. The loose concrete was removed on May 13, 1991. It is recommended that this area be inspected periodically to determine if further concrete delamination has occurred.

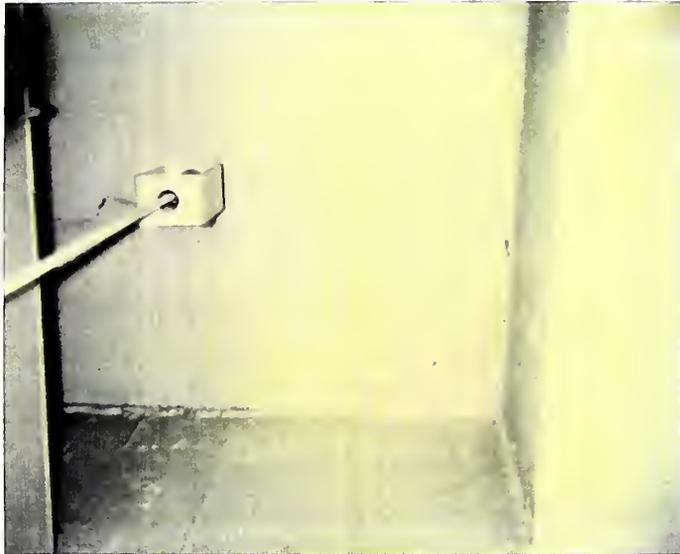
FIGURE 60

*BUILDING 233 ROOF SLAB, ROOM A121*

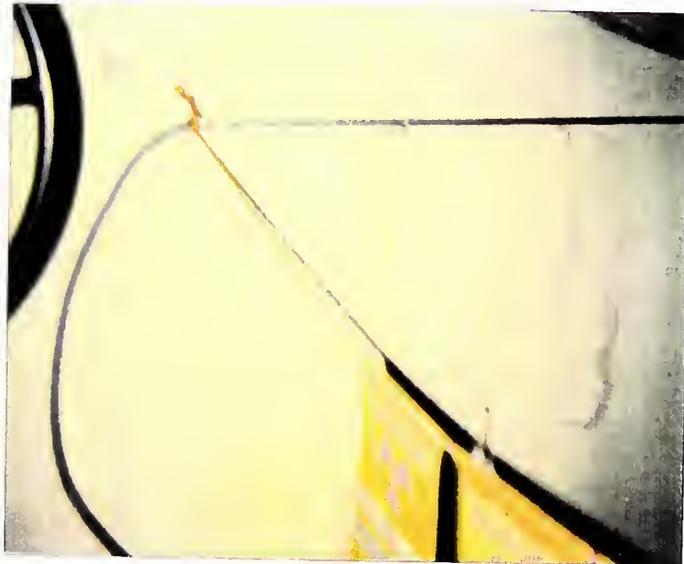
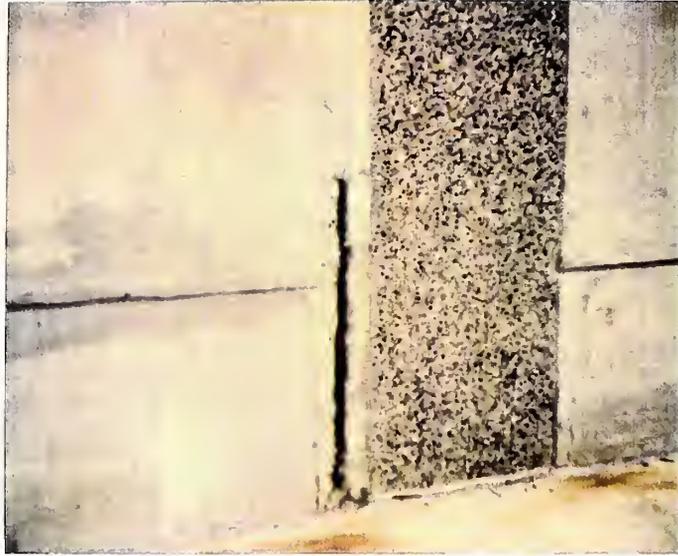
FIGURE 63

*BUILDING 235 ROOM C006*

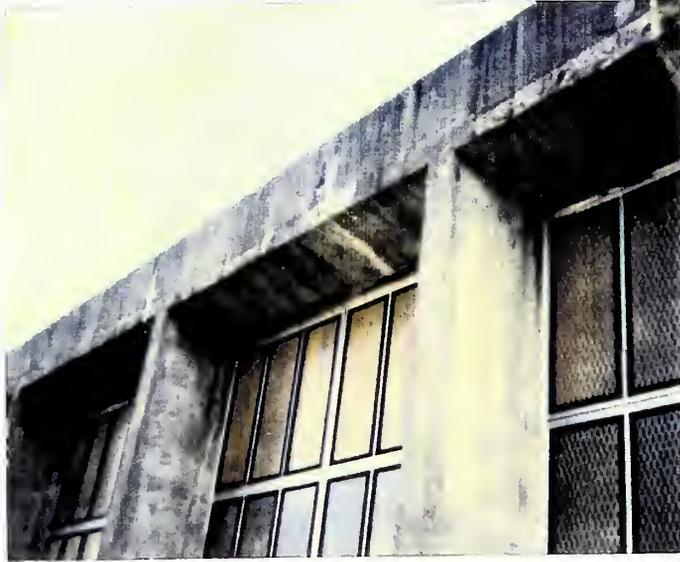
*BUILDING 235, WEST WALL*

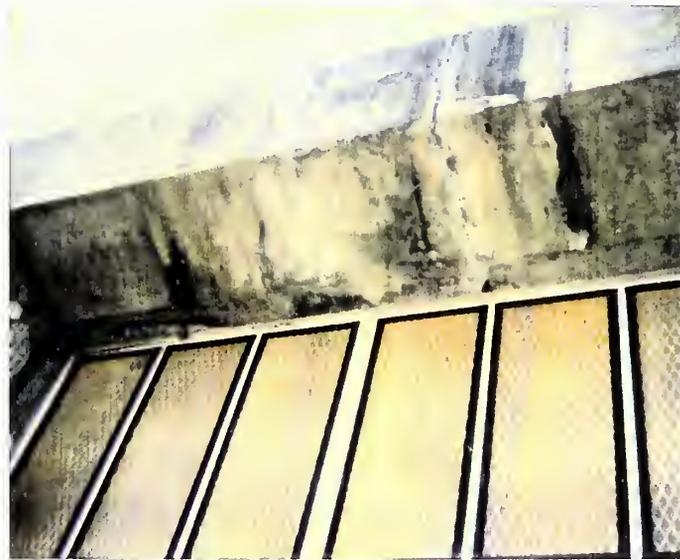
*BUILDING 236 - NORTH WALL*

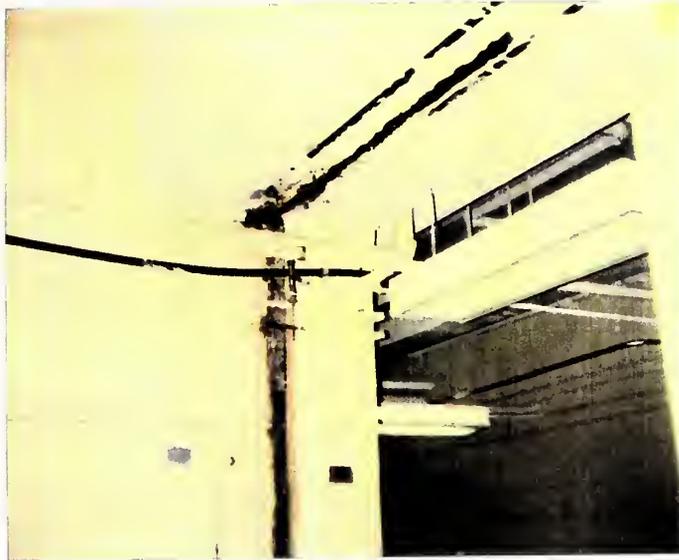
FIGURE 67

*BUILDING 245 - BASEMENT, ROOM A10*

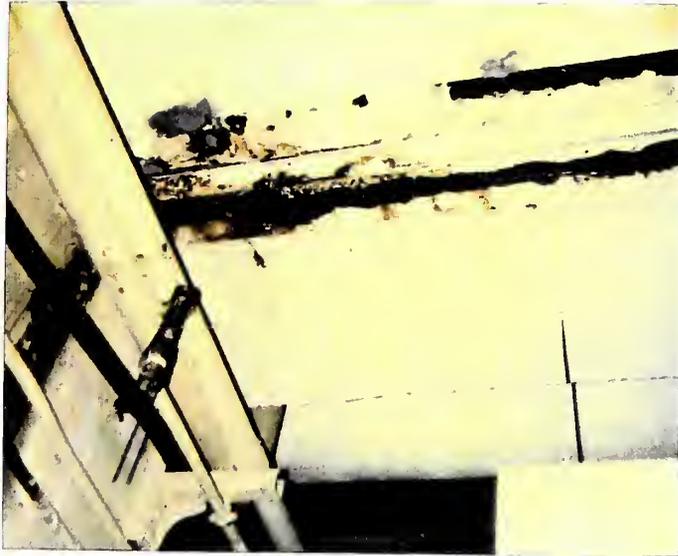
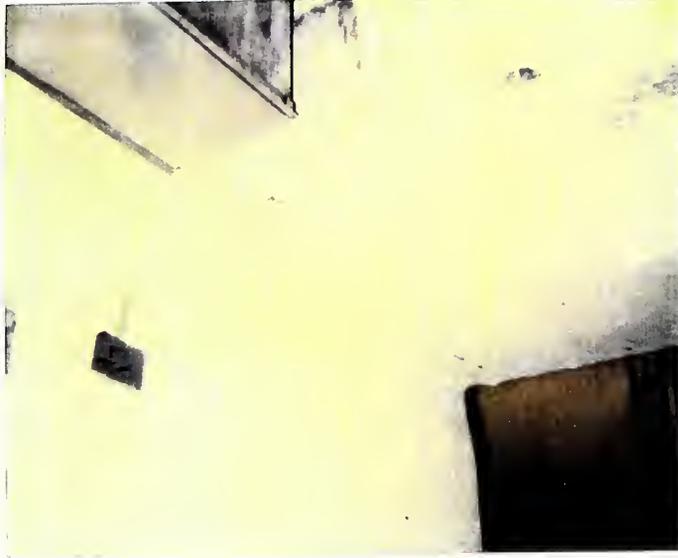
*BUILDING 245 - SUBBASEMENT EXPANSION  
JOINT*

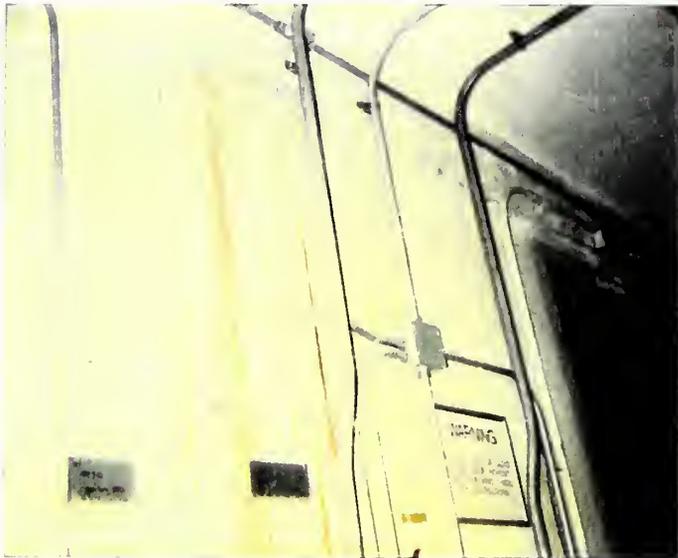
*BUILDING 245 - SUBBASEMENT, ROOM A008*

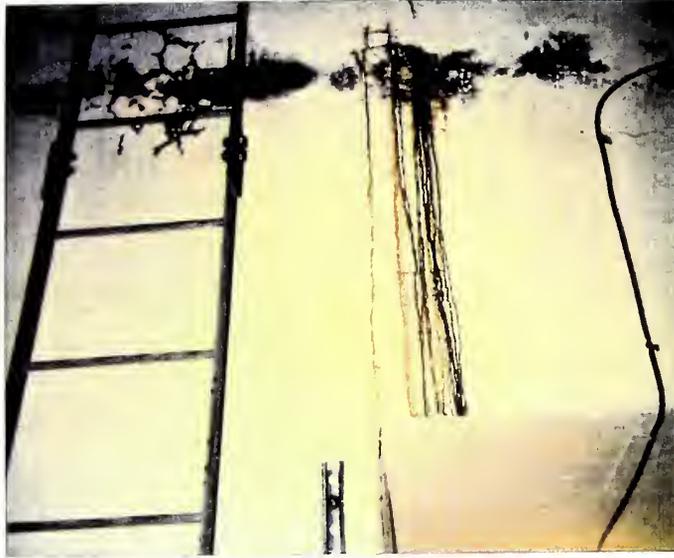
FIGURE 70

*BUILDING 245 - SUBBASEMENT, ROOM A007*

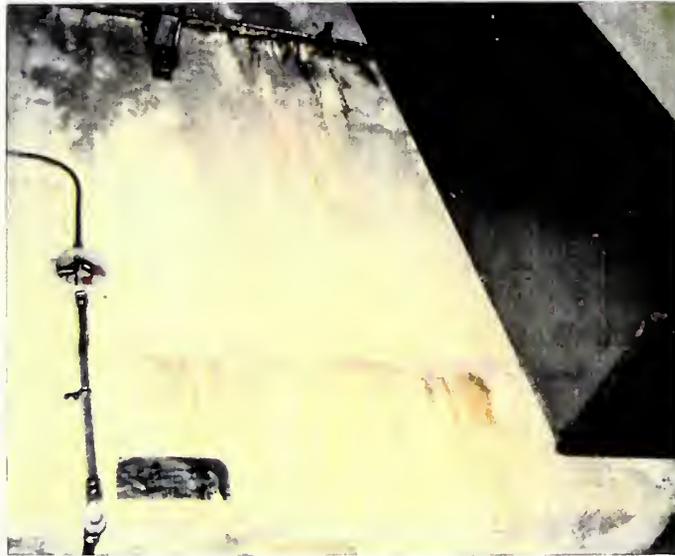
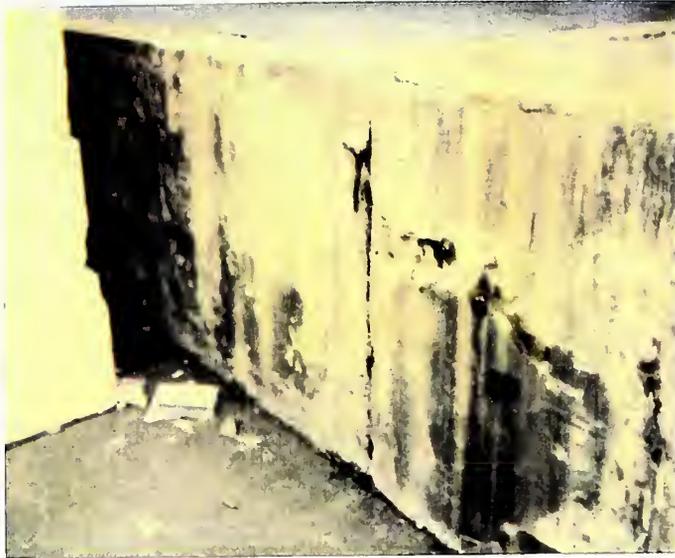
FIGURE 71

*BUILDING 245 - SUBBASEMENT, ROOM A008*

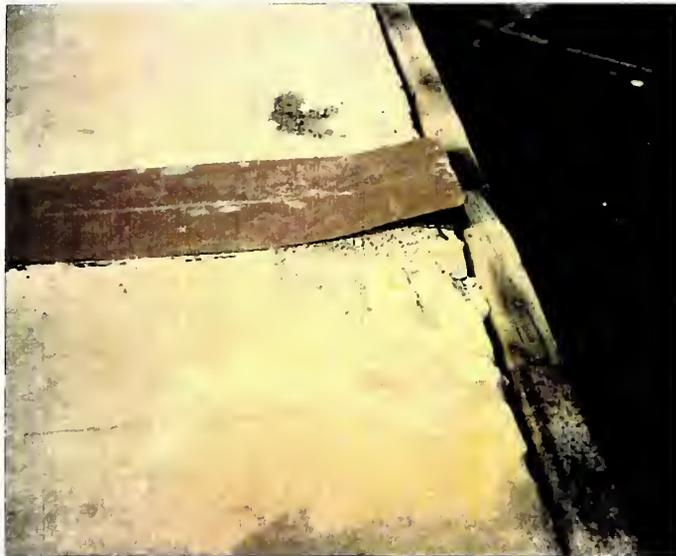
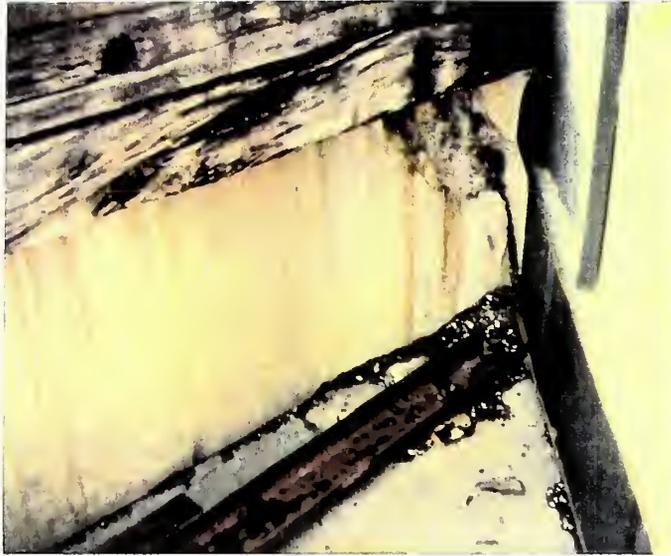
FIGURE 72

*BUILDING 245 - EAST LOADING DOCK*

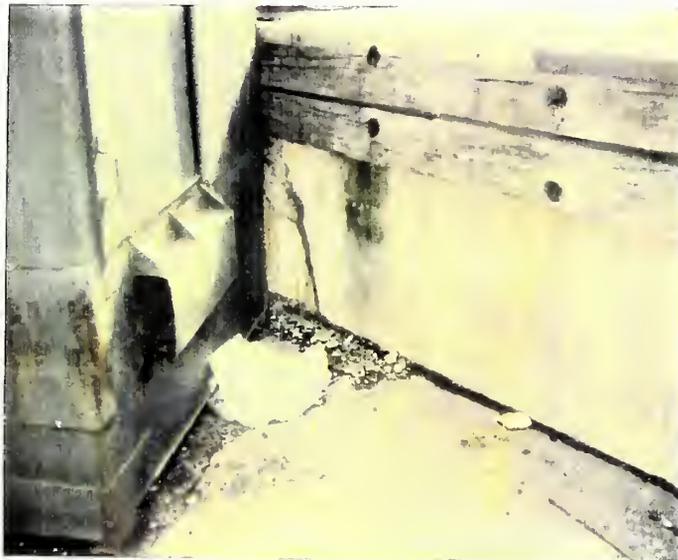
FIGURE 73

*BUILDING 245 - EAST LOADING DOCK*

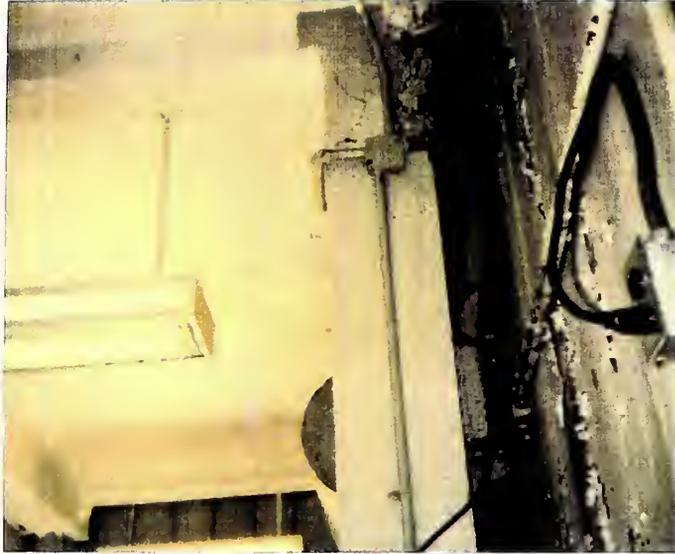
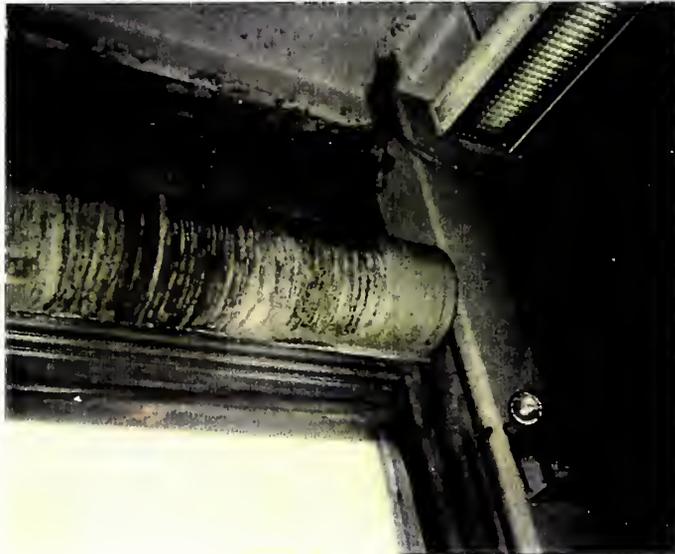
FIGURE 74

*BUILDING 245 - SOUTHEAST LOADING DOCK*

20. Bldg. 245, southeast loading dock, Rm. A120, crushed concrete at beam-column connection, about 4.6 m (15 ft) above the floor. The loose concrete was removed in 1991. It is recommended that this area be inspected periodically to determine if further concrete delamination has occurred. The concrete covering is apparently acting as fireproofing over steel shapes (need to verify presence of steel shapes). There is a white powdery material near or at the beam-column connection. Sampling and re-sampling of this material showed no asbestos using polarized light/dispersion staining microscopy.

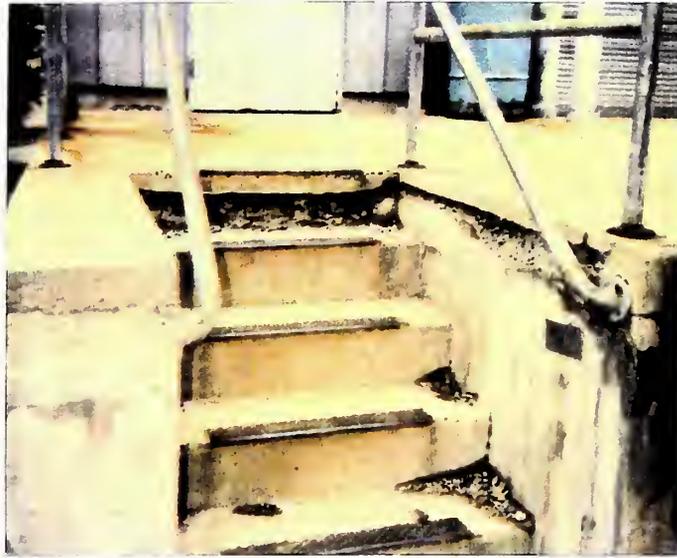
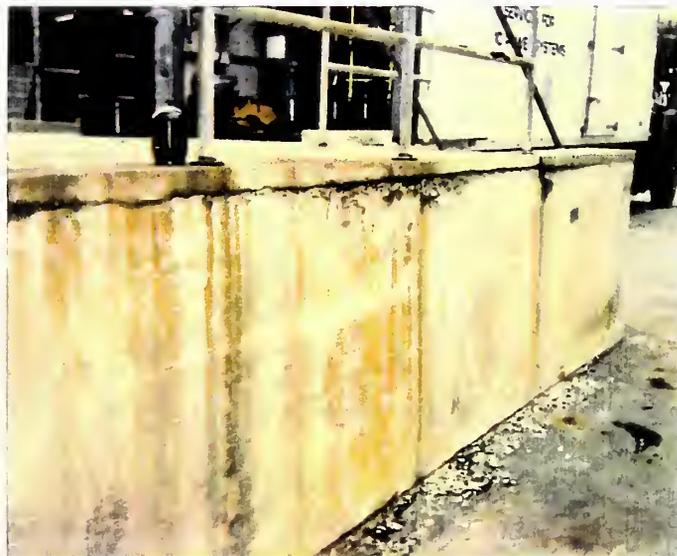
FIGURE 75

*BUILDING 245 - SOUTHWEST LOADING DOCK*

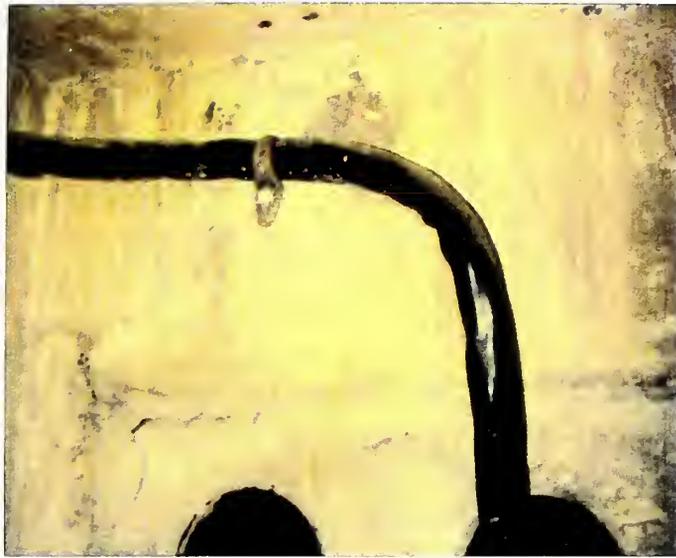
FIGURE 82

SIGNAL MANHOLE 13: WEST WALL, SEVERE DELAMINATION
